CE Power Solutions

Solutions Profile # 7 – 69 kV Circuit Switcher Replacement

Project Scope: Replace or repair a failed 69 kV, 20 kA, stored-energy Circuit Switcher located at a refuse burning Generating Stations' Substation, as quickly as possible

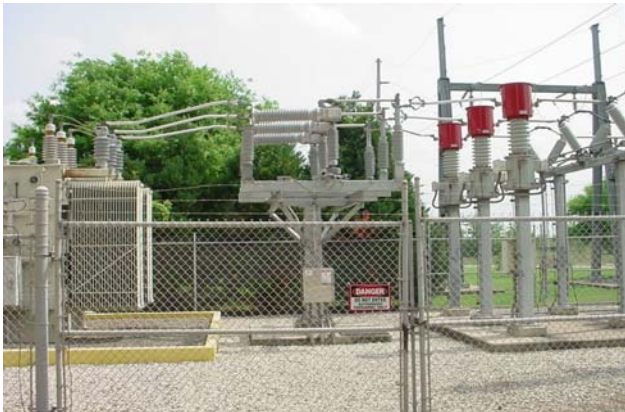
Project Profile: The 69kV Circuit Switcher failed on a Sunday. On Monday, CE Power was called and promptly went on-site to evaluate the failure. CE Power Field Services worked through the night on Monday in attempt to repair the switch. Tuesday, CE Power Field Services determined that the switch needed complete replacement. The customer agreed to replace the switch on Wednesday.

CE Power Solutions' Engineering Project Manager, experienced in substation construction, made inquiries to the switch manufacturers and discovered the components of the switch are available in 2-3 days – without the structure. Structure is reverse engineered, material and plating is specified, ordered and delivered at the site in coordination with the major switch components. CE Power Field Services, under the direction of the Project Engineer, remove the existing failed unit and construct the new switch installation. In addition, the associated transformer was tested and CTs rebuilt while the switch was being assembled.

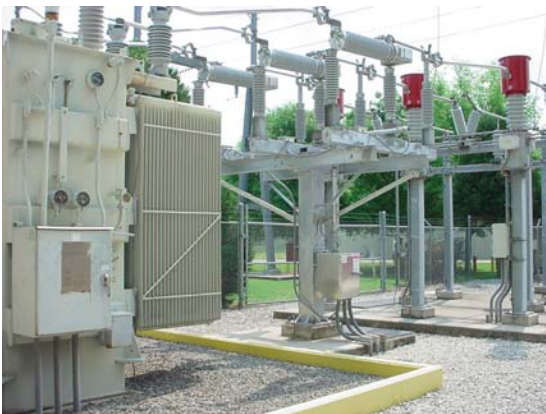
Circuit Switcher was put in service on the following Tuesday – 8 days after the failure and 6 days after coming to the conclusion on what had to be done to get the IPP back online.

Solution is delivered in 6 days and the generating Unit is put back on line in (8) days after initial failure!
